**TOWN OF MEDLEY
WASTEWATER DEPARTMENT**

Wellfield Cone of Influence (COI) Addendum

Medley Project No.: WS-0142

Snubbs Project No.: 1401-030

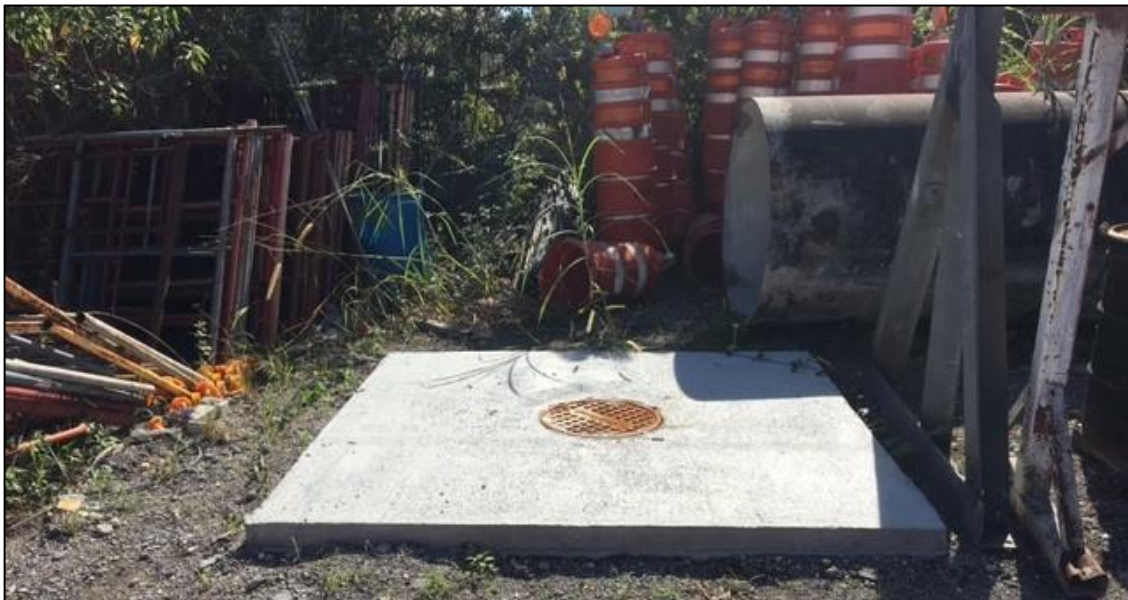
Pump Station 1 Basin consists of 47 manholes, which all fall within the Hialeah Preston Wellfield COI. Out of the 47 manholes, 1 manhole (MH-9) was identified as misaligned during the inspections conducted on 7/15/2016. This manhole was repaired by the Town on 11/30/2016. See **Figure 3-1**.

Figure 3-1: MH 9 Completed Repair

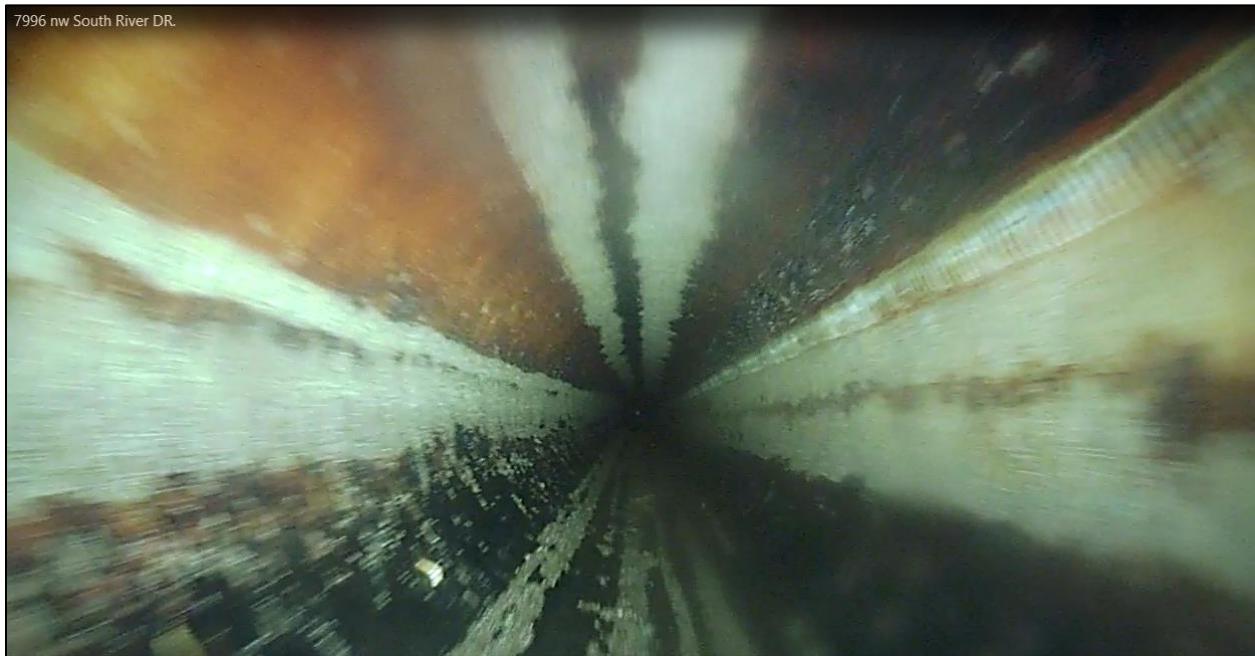
Out of the 11,600 LF of sewer mainlines located in PS-1 Basin, 10,800 LF were CCTV inspected between the periods of 5/30/2013 and 7/01/2016. Based on the review of the CCTV videos, approximately 450 LF of sewer mainlines, between MH 5A to MH 5 and MH 1-2-6 to MH 1-2-5, were identified with mild Deposits Attached Encrustation (DAE). In addition, 3 mainline segments (MH-4 to MH-5, MH-7 to MH-8 and MH-4 to MH-1-3-D) were identified with a minor deficiency each.

Figure 3-2: Cleaned Mainline between MH 1-2-6 to MH 1-2-5

On 12/14/2016, the gravity mainline between MH 5A and MH 5 was cleaned and CCTV'd to remove the mild DAE. Report is included in **Appendix C**. The mainlines between MH 1-2-6 to MH 1-2-5 were cleaned by the Town on 1/11/2017, see **Figure 3-2**.

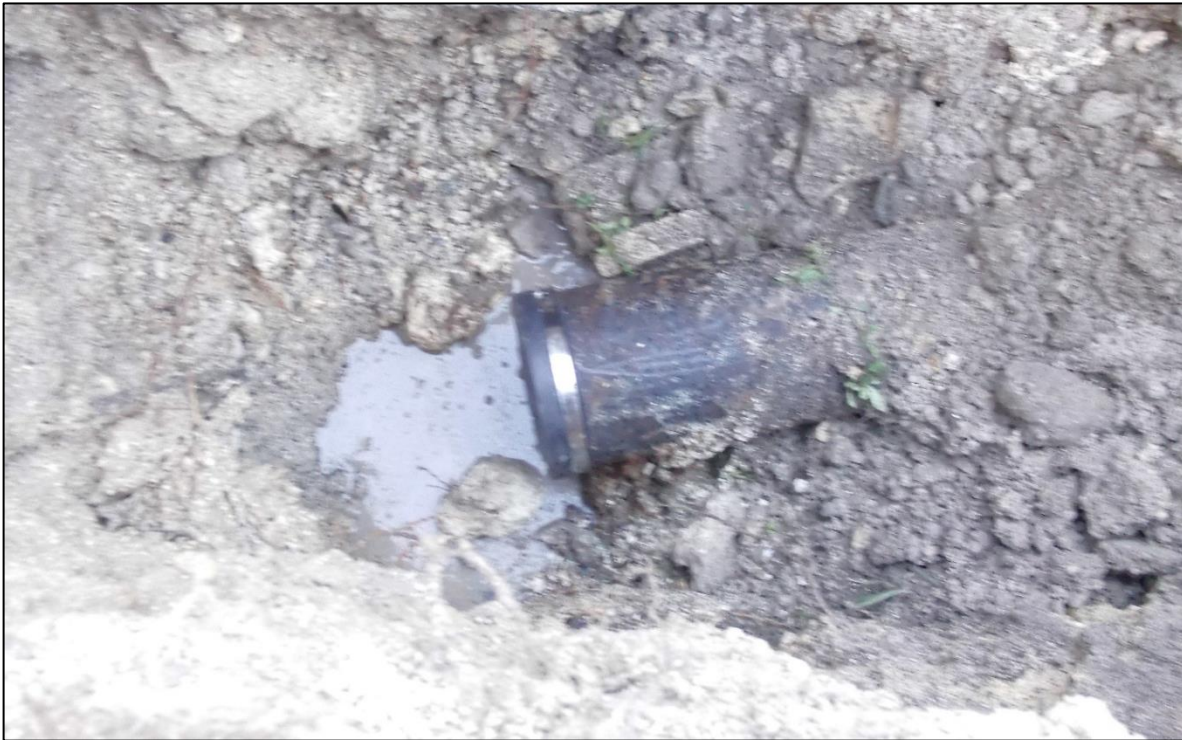
A new CCTV inspection of approximately 330 LF of gravity mainline between MH-5 and MH-4 was performed on 12/14/16. See **Appendix C**. During the review of the video, potential I/I sources were observed at the 2 laterals located at 76 ft. and 204 ft. from the upstream MH-5. These 2 laterals are located at an area of vacant land. During the visual inspection, a crack was observed in each of the two laterals. A such, both laterals were repaired on 1/10/2017. See **Figure 3-3**. This mainline segment was cleaned and re-CCTV inspected on 1/25/2017. The review of this video confirmed that the sources of I/I at those 2 locations were addressed. Refer to **Appendix C**.

Figure 3-3: Repair of Lateral between MH 5 – MH 4

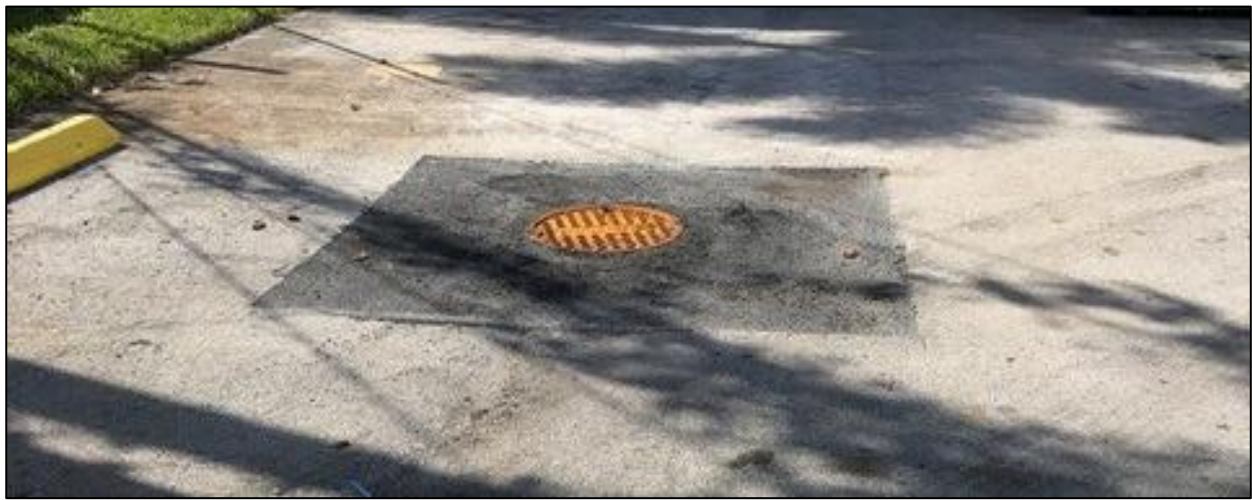
Pump Station 100 Basin consists of 70 manholes 27 of them fall within the Hialeah Preston Wellfield COI. These manholes were visually inspected between the period of 6/14/2016 and 6/22/2016. Two manholes (MH-100-6-2 and MH-103-5) were identified with deficiencies. Rain guards did not fit at both manholes due to the ring and cover alignment. Manholes MH-100-6-2 and MH-103-5 were repaired on 12/13/2016 and 1/17/2017, respectively. Refer to **Figure 3-4** and **Figure 3-5**.

Figure 3-4: MH 100-6-2 Completed Repair

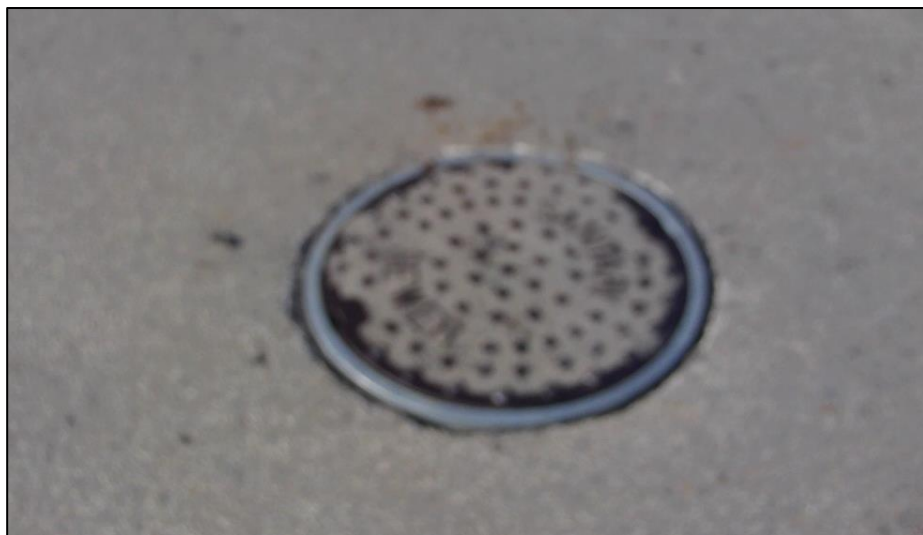
Figure 3-5: MH 103-5 Completed Repair

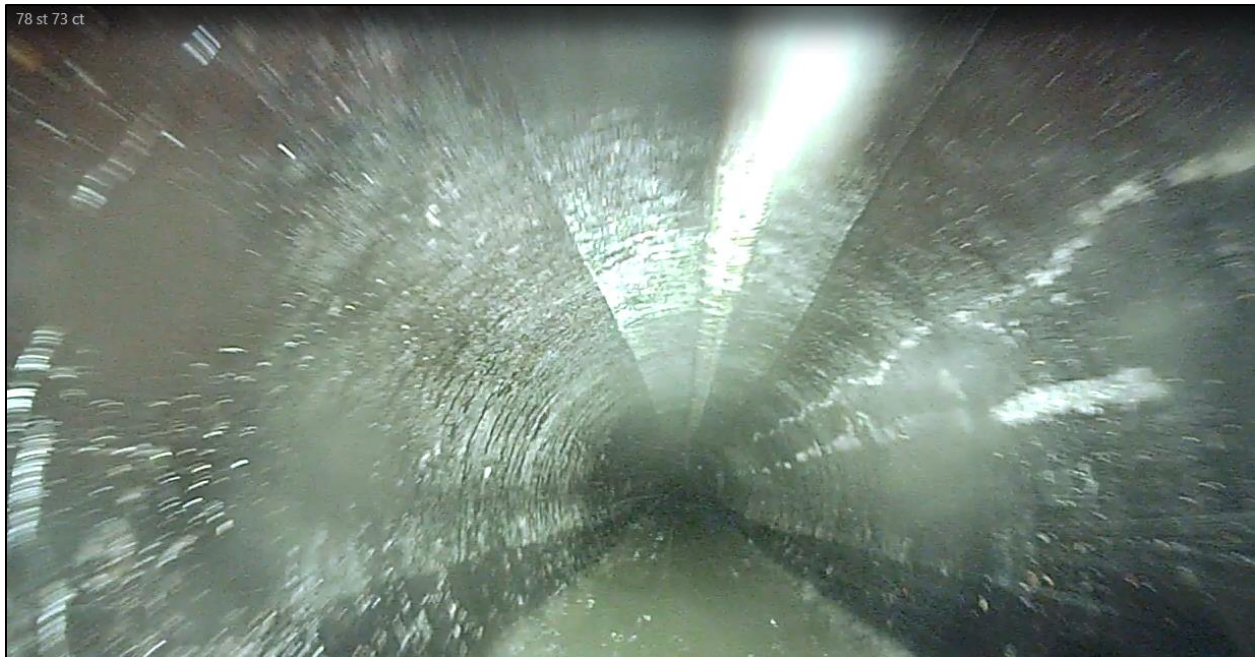
Pump Station 100 Basin has approximately 8,860 LF of sewer mainlines located within the wellfield COI. These sewer mainlines were CCTV'd between the periods of 1/28/2013 and 7/19/2016. Based on a review of CCTV reports and videos, approximately 400 LF of sewer mainlines between MH-101-2 and MH-101-3 were identified with mild Deposits Attached Encrustation (DAE). In addition, 2 mainline segments (MH-100-6-1 to MH-100-6-2 and MH-100-3 to MH-100-4) were identified each with a minor deficiency.

Figure 3-6: PS-1 Mainline Cleaning MH 101-2 to MH 101-3

On 1/11/2017, the gravity mainlines between MH 101-2 and MH 101-3 were cleaned to remove minor DAE, see **Figure 3-6**.

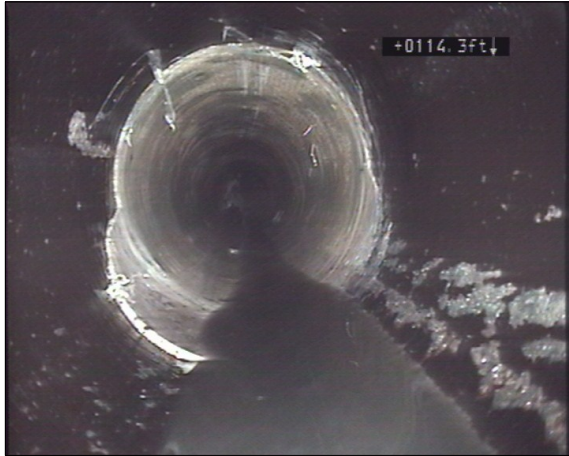
Photo: 001_8-7_20022017_001.JPG, VCR No.: 014
115FT, Repair Localized Liner, within 8 inches of joint: NO,
Start

An undercut of the lining at the lateral joint and sources of I/I from that lateral were observed at the gravity mainline between MH-7 and MH-8. These faults were located at 120 ft. from the upstream MH-8. On 2/20/2017, a sectional lining repair was performed to address these faults. Based on the post-sectional CCTV video, no sources of I/I were observed. The CCTV inspection report is included in **Appendix C**. The CCTV video is on the CD attached to the hardcopy of this addendum.
