**TOWN OF MEDLEY
WASTEWATER DEPARTMENT**

Wellfield Cone of Influence (COI) Addendum

Medley Project No.: WS-0142

Snubbs Project No.: 1401-030

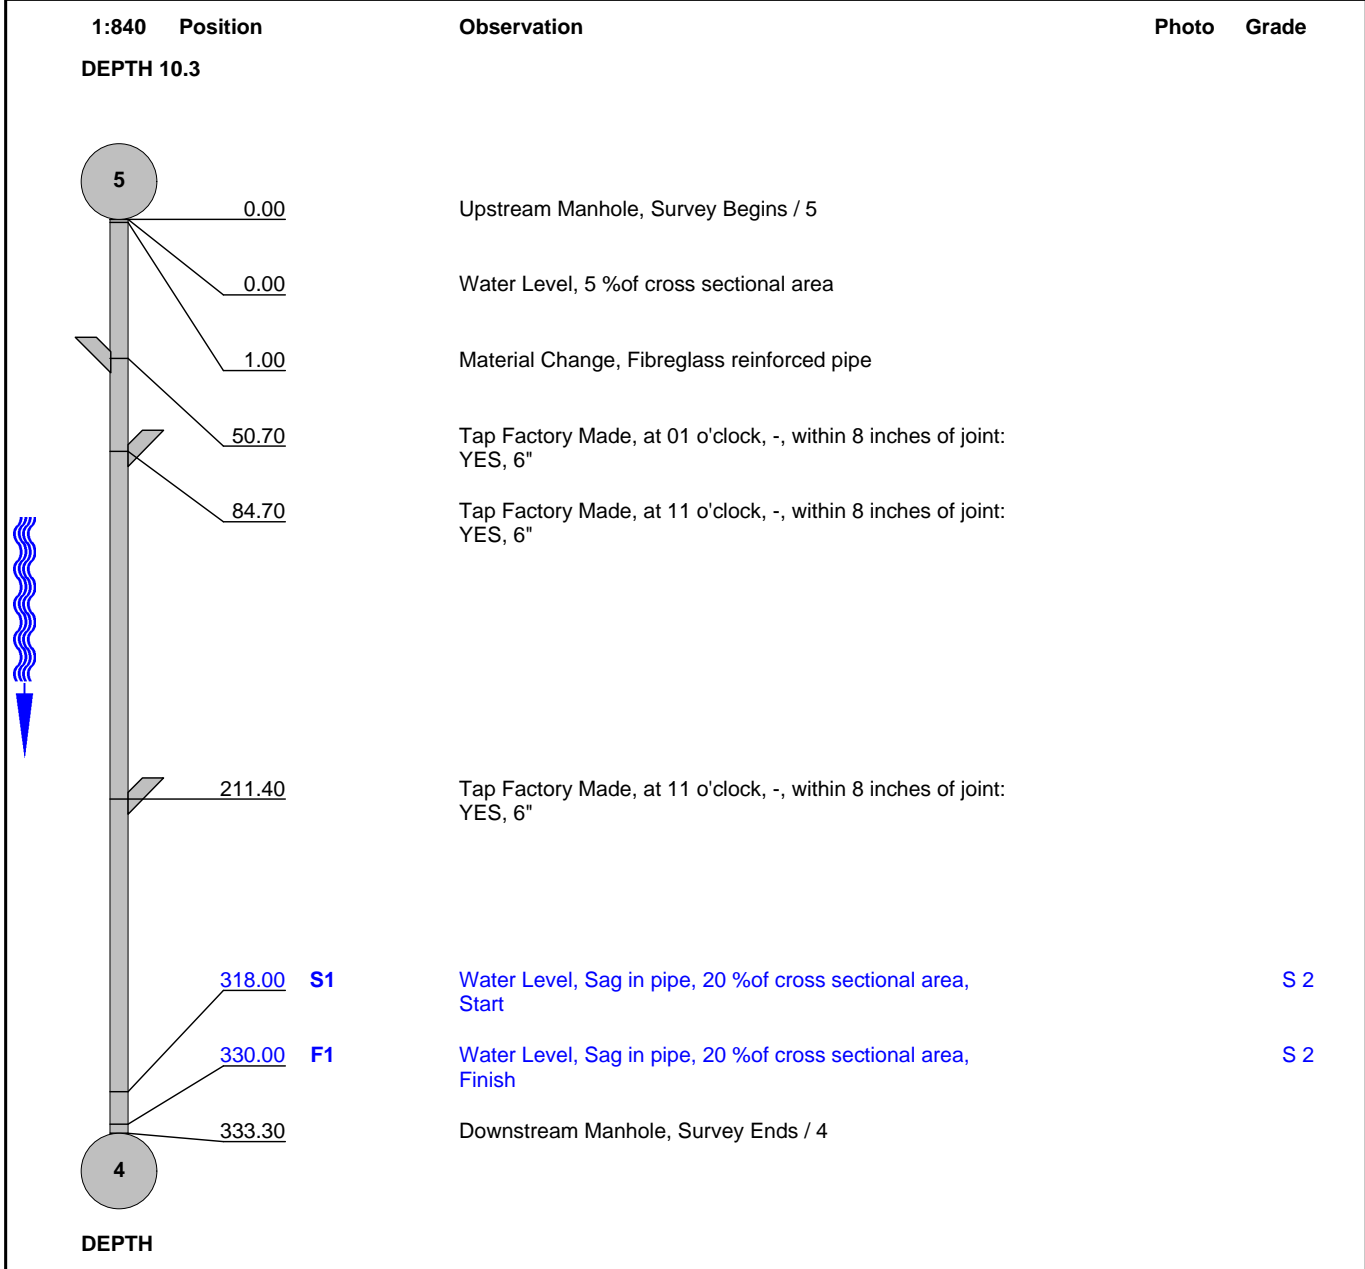
Purpose of Survey Year Laid Year Rehabilitated Tape / Media No.	Infiltration/Inflow Investigation 013	Joint Length Dia./Height Material Lining Method	0.00 ft 8 inch Not Known Cured in Place
--	--	--	--

QSR	QMR	SPR	MPR	OPR	SPRI	MPRI	OPRI
2100	0000	2	0	2	2	0	2

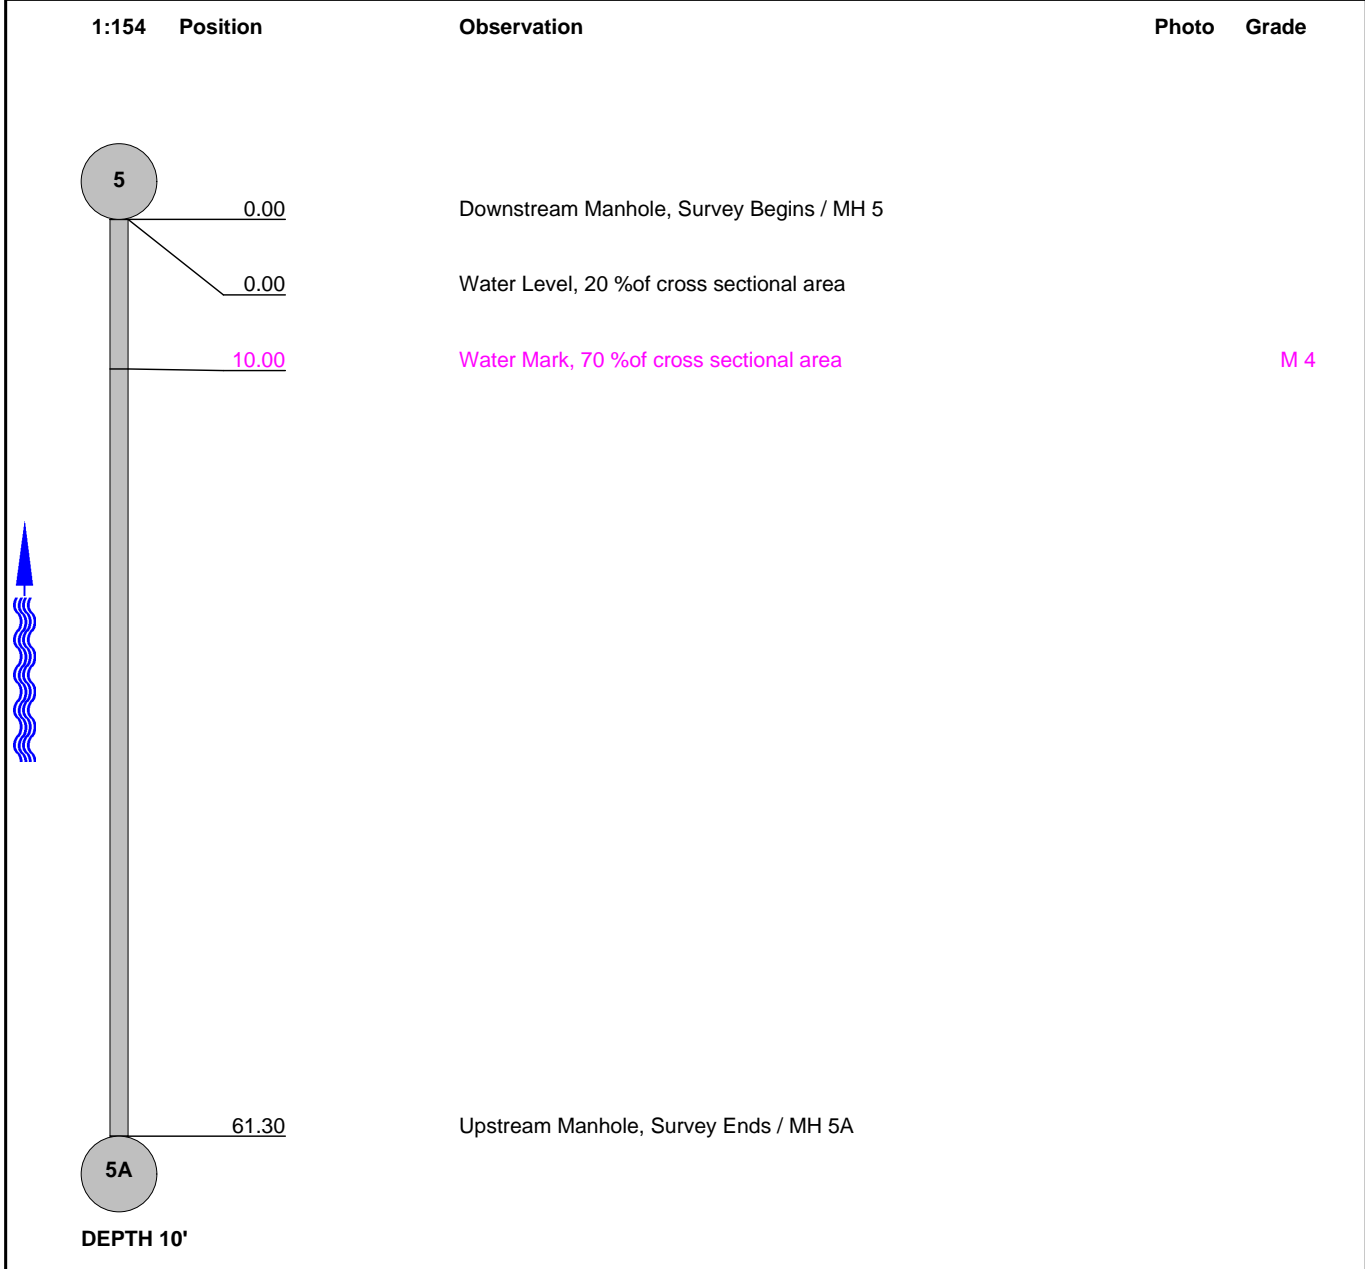
Purpose of Survey Year Laid Year Rehabilitated Tape / Media No.	Infiltration/Inflow Investigation 011	Joint Length Dia./Height Material Lining Method	0.00 ft 8 inch Not Known Cured in Place
--	--	--	--

QSR	QMR	SPR	MPR	OPR	SPRI	MPRI	OPRI
0000	4100	0	4	4	0	4	4
